Urban legends for the European Parliament?

In March 2015 the Polish “Parliamentary Committee for Investigation of the Tu-154M Crash” presented a paper on the causes of the 2010 crash of the Polish presidential aircraft in Smolensk to the members of the European Parliament. It's utterly astonishing that the paper refers to the Russian IAC (MAK) report, disregarding the official report prepared independently by the Polish state commission and published in July 2011.

Errors, misconceptions, urban legends and lies in the Committee's paper

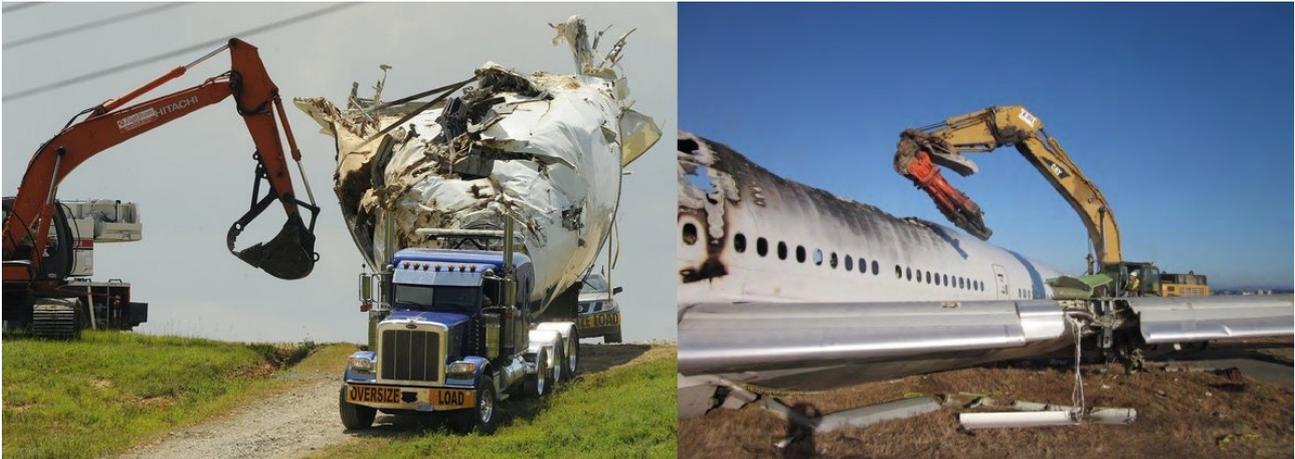
Cutting of large wreckage parts before removal from the crash site is often required and is a normal procedure – ask AAIB, BEA, BFU, NTSB or other aviation accident investigation agency. Wreckage condition has been documented (photographed) prior to removal.

Fig 1: Heavy equipment used to remove aircraft wreckage. Left: Birmingham-Shuttlesworth, Alabama UPS 1354 crash (Source: al.com), Right: San Francisco, California Asiana 214 crash (Source: nycaviation.com)

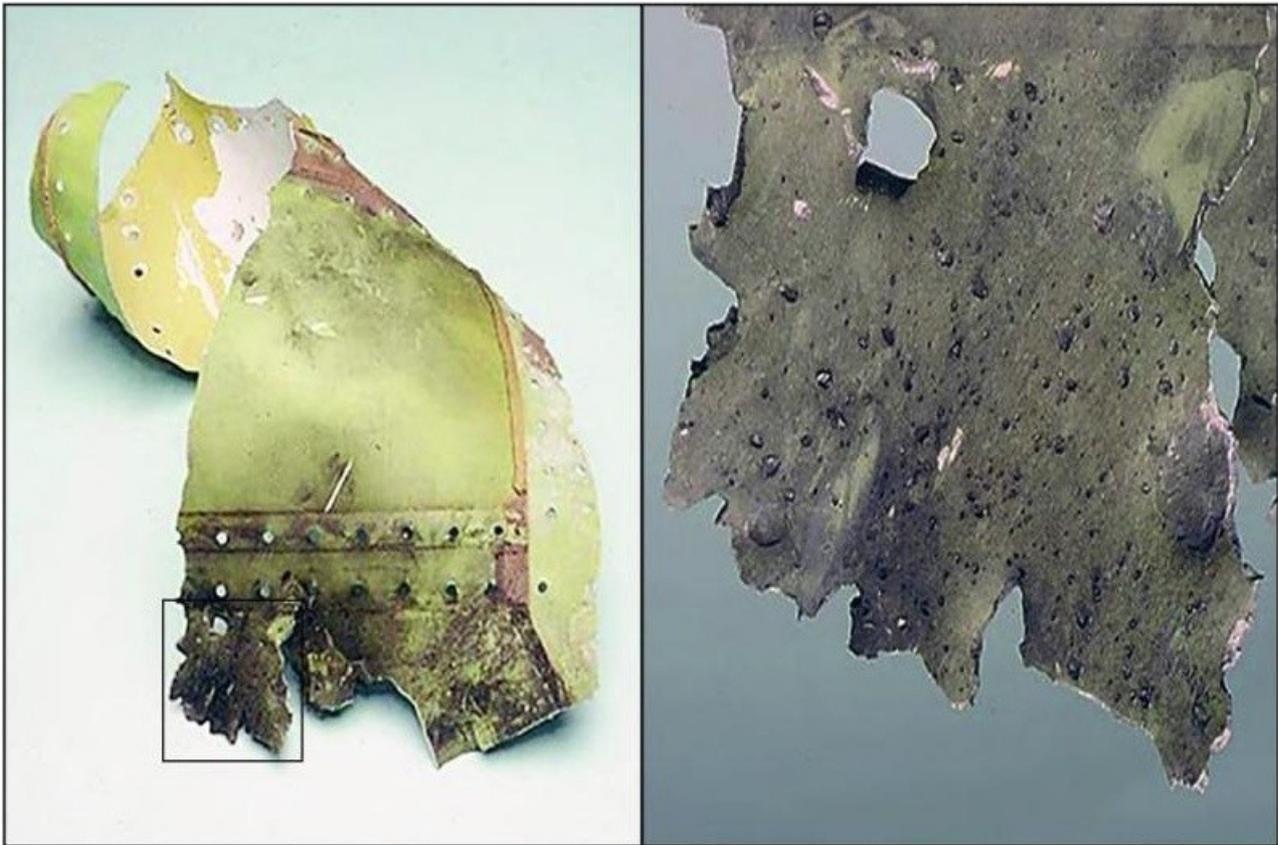
There's no evidence of inflight explosion at all. Airframe fragments found outside areas of post-crash fire were not sooted, no debris exhibit marks typical to explosion, like petalling or pitting. No debris from inside the fuselage were found before ground scars, so the fuselage was destroyed on impact with ground.

Fig 2: An example of concentration of staining and microcraters with some gas wash near the tip of a curl from a petaled hole torn in an aircraft fuselage by explosion. **No such marks have been found in Smolensk.** (Source: *Forensic Investigation of Explosions*, CRC Press, © J. Garstang)

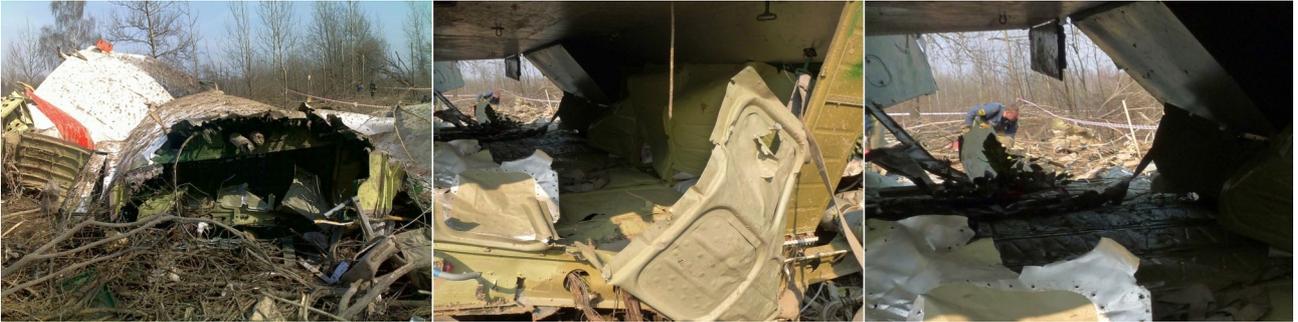
This assumption is just silly. Condition of the wreckage was documented on photographs. What's important, the cargo hold ceiling visible in this part of wreckage, which was also the cabin floor, can be seen perfectly flat, what would not be the case after an explosion in the fuselage.

Fig 3: A look inside the cargo hold reveals perfectly flat ceiling (now at bottom) being also the cabin floor, that would be buckled or destroyed in case of explosion in the fuselage.

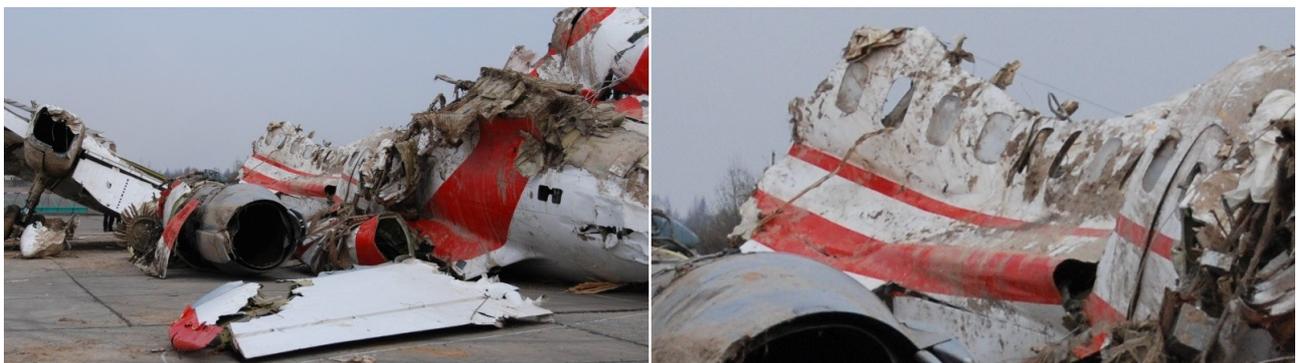
It's a lie. Most of window panes can be seen intact on photographs from the storage site on the Smolensk Severny aerodrome. A few were broken to hoist large fuselage parts from the crash site (a rope remaining in a broken window can be seen on photographs from the storage site).

Fig 4: A rope used to hoist large fuselage part can be seen remaining in a broken window on a photograph from the storage site

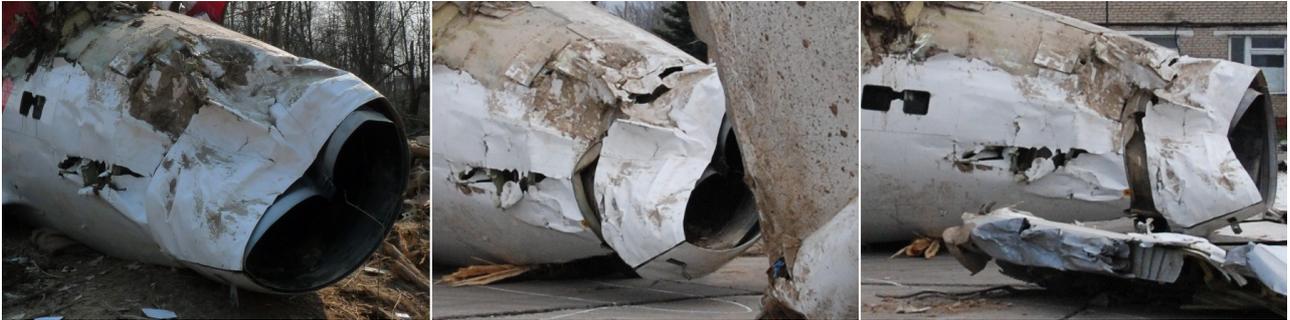
It's an urban legend. Deformed engine #2 exhaust nozzle can be seen on photographs from the storage site on the Smolensk Severny aerodrome.

Fig 5: An urban legend presented to the European Parliament: “deformation of aircraft tail has been 'repaired' even before it was moved to storage site”. Deformed engine #2 exhaust nozzle seen on photos from the crash site (left) and storage site on the Smolensk Severny aerodrome

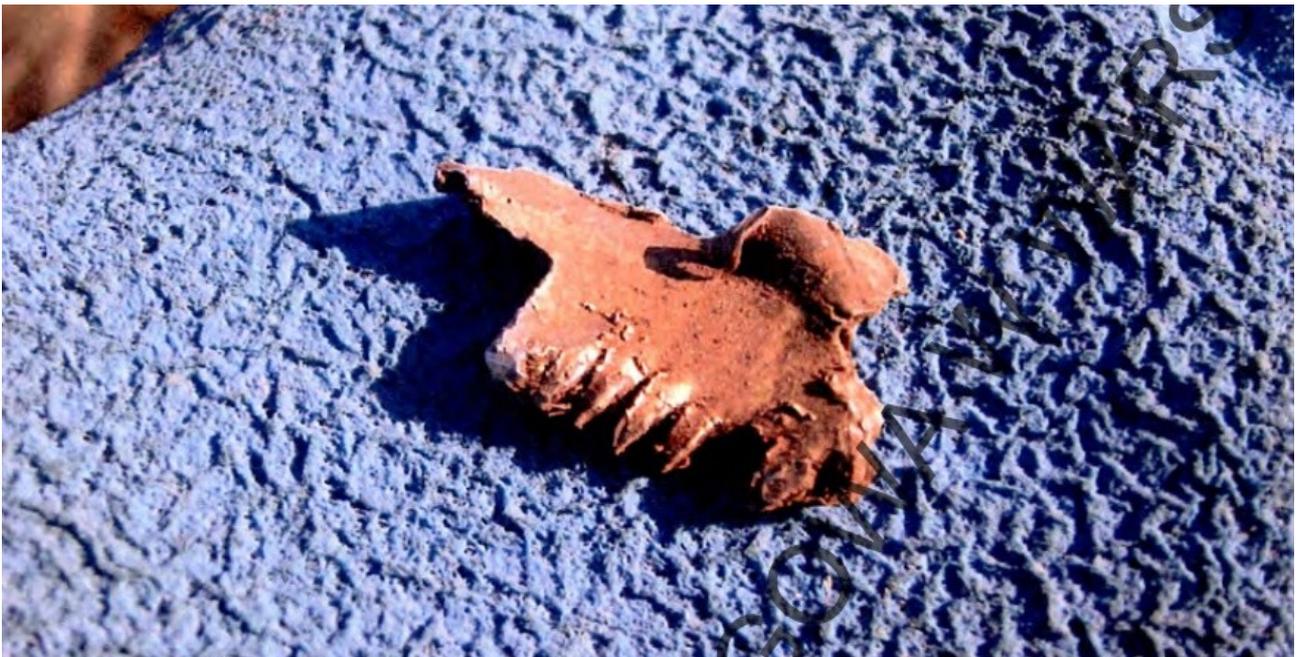
Smolensk Archeologists' report says: "Perhaps they were burned/sooted due to passing through hot turbines". Indeed, marks left by tips of rotating turbine blades can be seen on a photo in the report.

Fig 6: Marks left by tips of rotating turbine blades on a small metal fragment suggest it has been ingested by one of plane's engines – photo from the Archeologists' Report

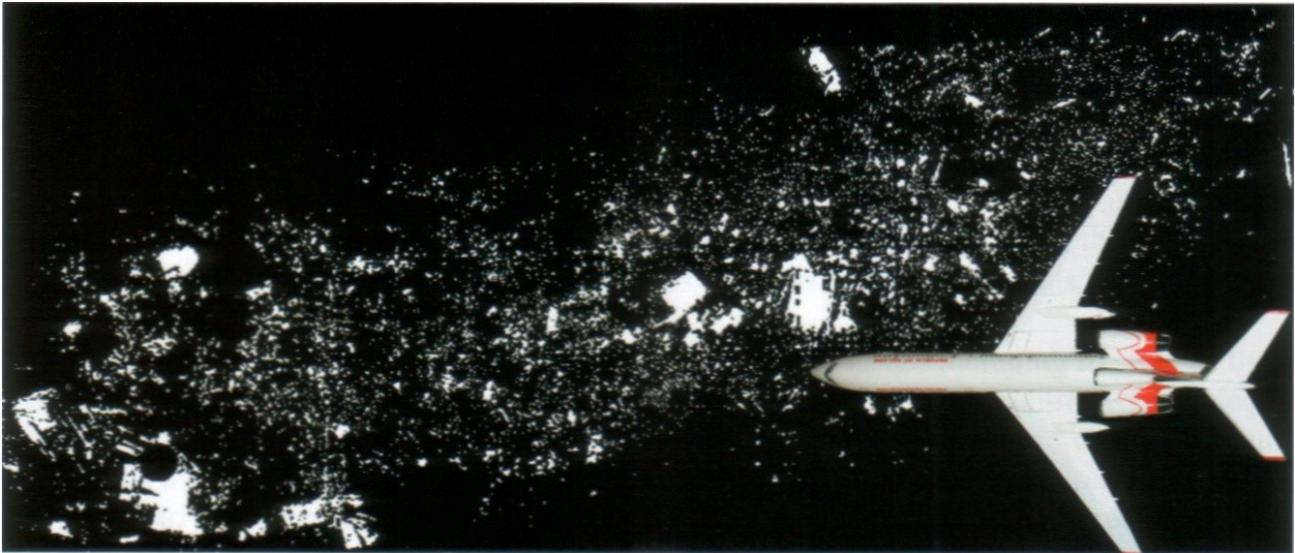
Elongated shape of the debris field is consistent with shallow impact with ground. Besides, the debris field that the paper refers to starts with the first ground impact point.

Fig 7: Elongated shape of the main debris field is consistent with shallow impact with ground. Narrow width contradicts the explosion theory. Point of the first impact is just outside the top-right corner of the picture.

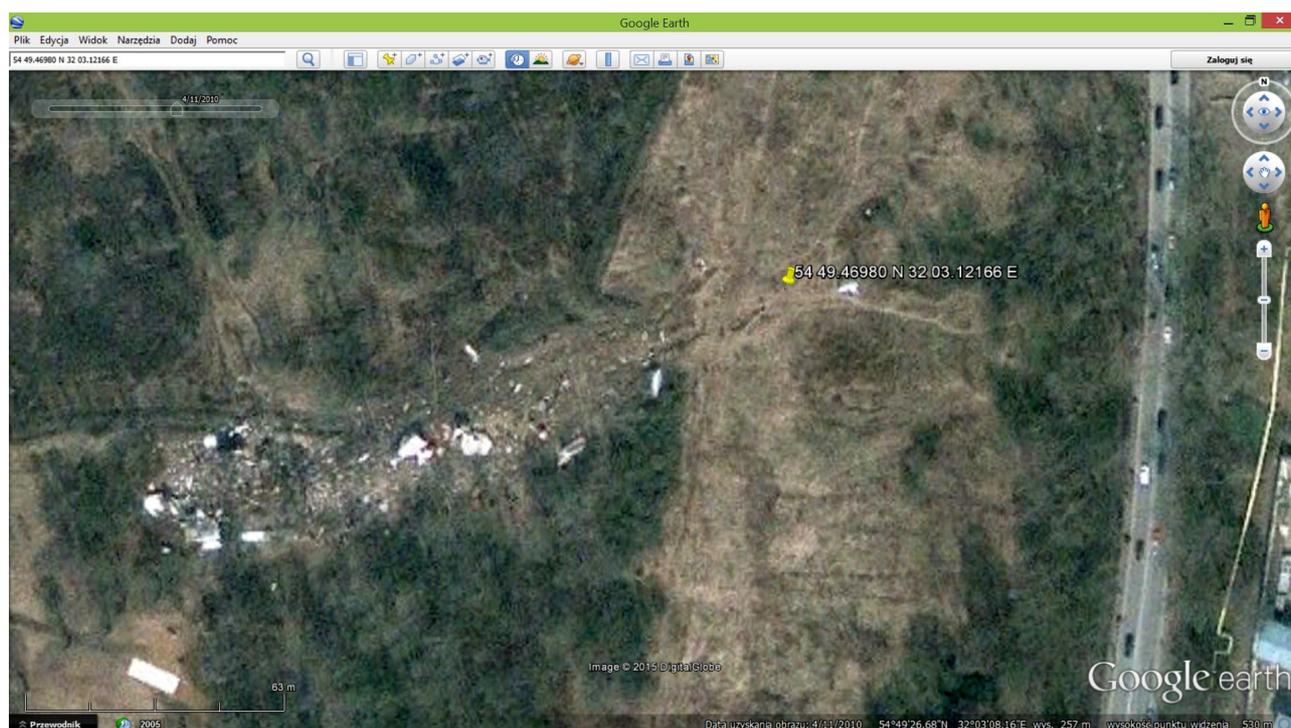
The FMS data contains last recorded coordinates from three onboard GPS receivers. All of them point exactly to ground scars marking first impact with the ground – and this is where power was lost due to disintegration of the fuselage. Everyone can check it just by entering these coordinates into the Google Earth search field.

Fig 8: Last GPS coordinates recorded by FMS computer match exactly the point of ground impact

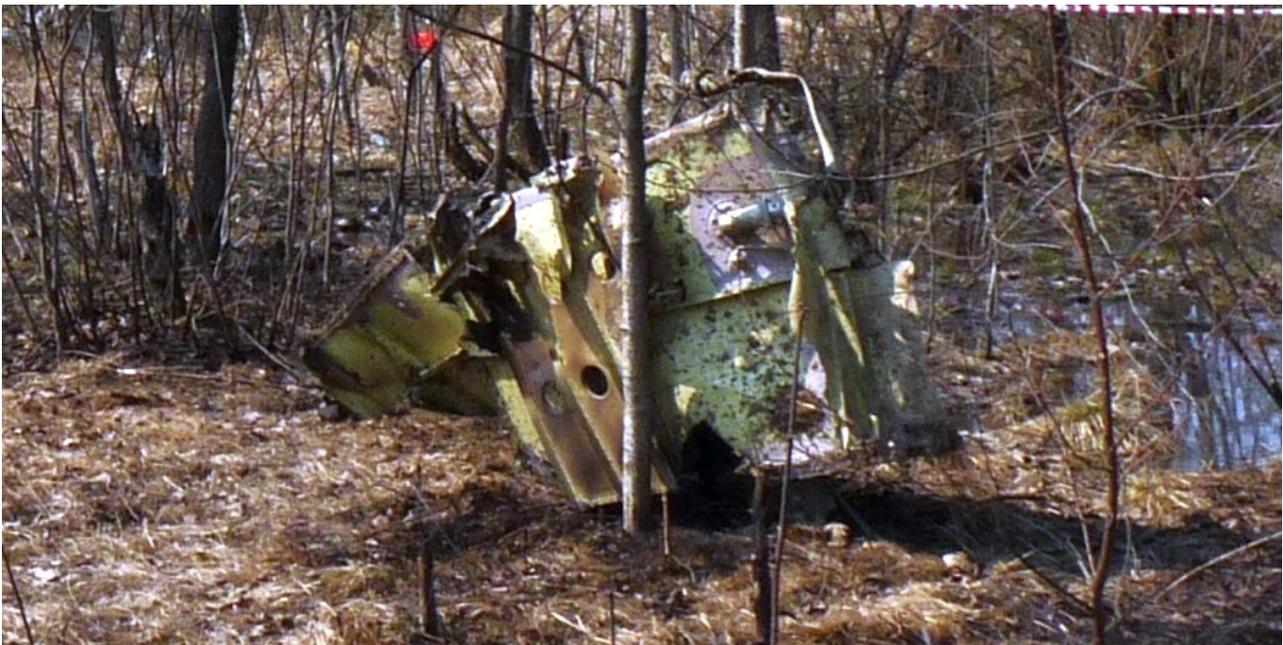
Sooting visible on the structure was caused by the post-impact fire, that also charred the grass below it. By the way, it's a fragment of wing spar, not a wing box.

Fig 10: Soot on the fragment of wing spar was not left by explosion, but by small post-crash fire that also burnt the grass

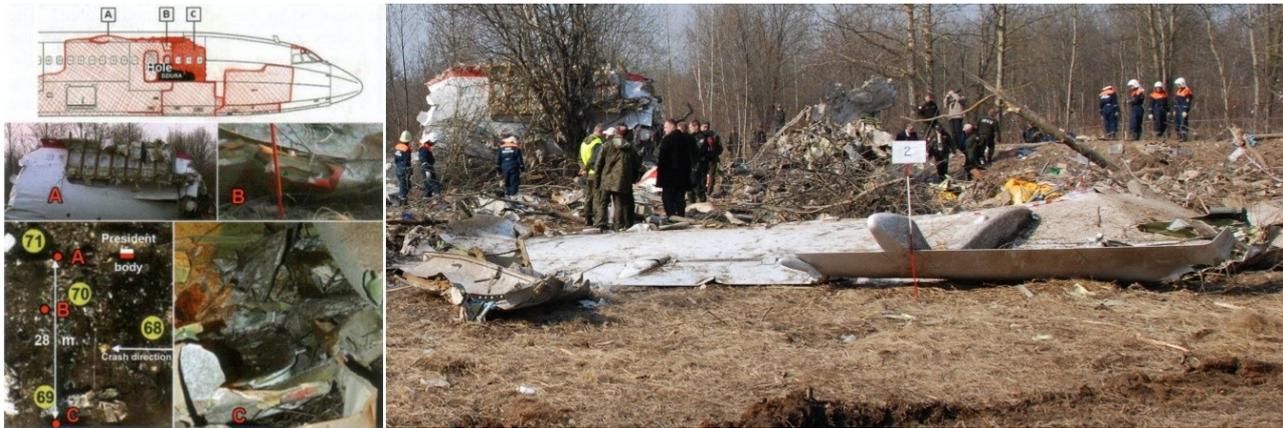
Several detailed photographs taken at the point C reveal no part resembling fuselage wall with windows, but fragments of the right wing instead.

Fig 11: No fragments of the fuselage at “point C” (right), just fragments of the right wing. Remains of the president's suite (“point A”) visible behind a tree.

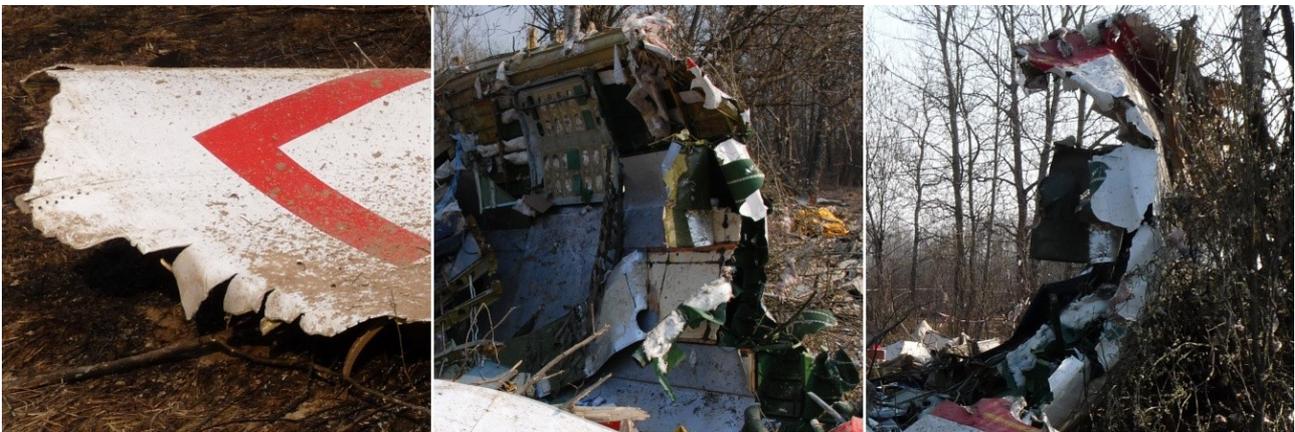
Photos show edges bent outwards as well as inwards.

Fig 12: Edges of fragments were bent outwards as well as inwards
